Perspectives on the Boeing 737MAX MCAS

Ron Carson, PhD, ESEP, INCOSE Fellow

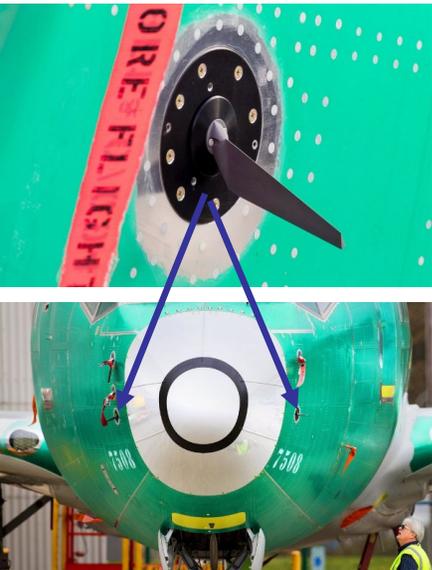
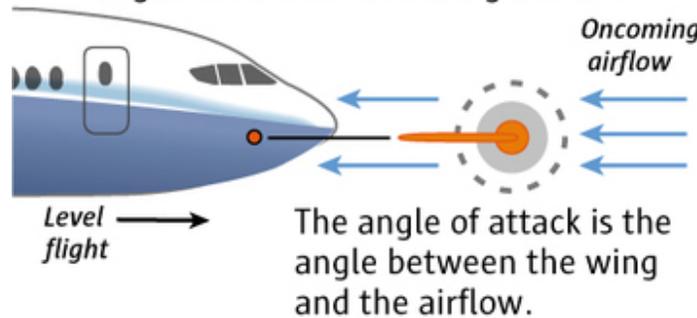
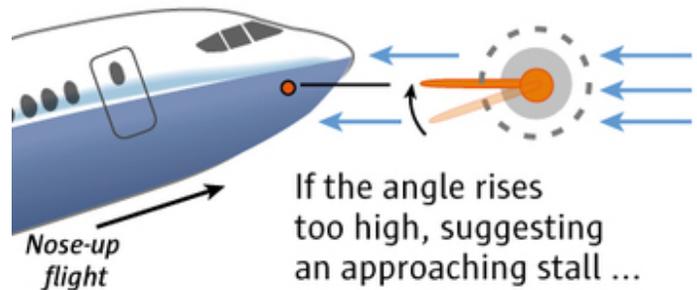
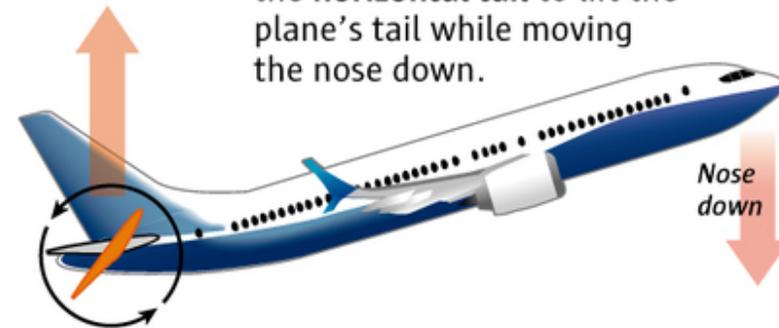
How the MCAS (Maneuvering Characteristics Augmentation System) works on the 737 MAX

1. The angle-of-attack sensor aligns itself with oncoming airflow.

2. Data from the sensor is sent to the flight computer.

... the MCAS activates.

3. MCAS automatically swivels the horizontal tail to lift the plane's tail while moving the nose down.

In the Lion Air crash, the angle-of-attack sensor fed false information to the flight computer.

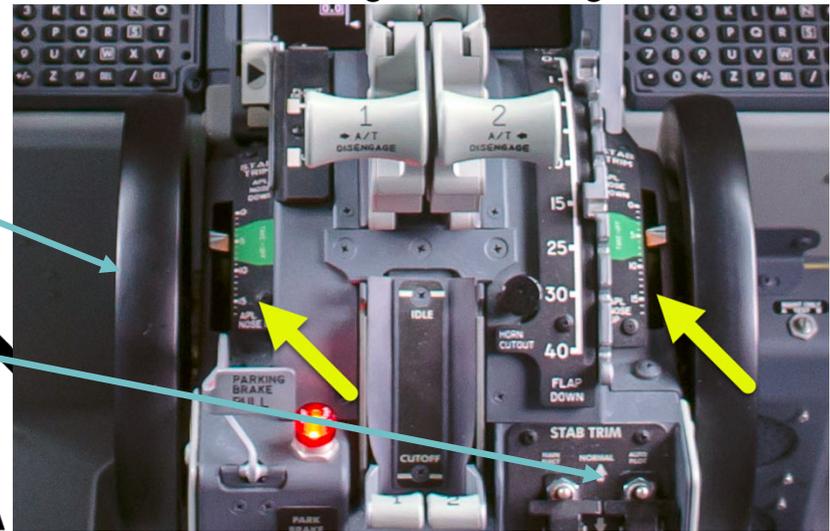
MCAS uses input from **ONE** AOA sensor, alternating between flights

- Single failure of AOA is not reported to pilots
- Erroneous AOA input can cause MCAS to announce “stall” and pitch nose down
 - Assumption: pilots would quickly recognize and could override MCAS by turning it off and manually control the horizontal stabilizer via the wheels on the center console
- Pilots
 - Don't know about MCAS (automation)
 - May react to erroneous stall warning by pushing nose down, **as trained**
 - May not be able to override horizontal stabilizer position because of forces at high speeds
- MCAS can self-reactivate (multiple pitch-down commands)

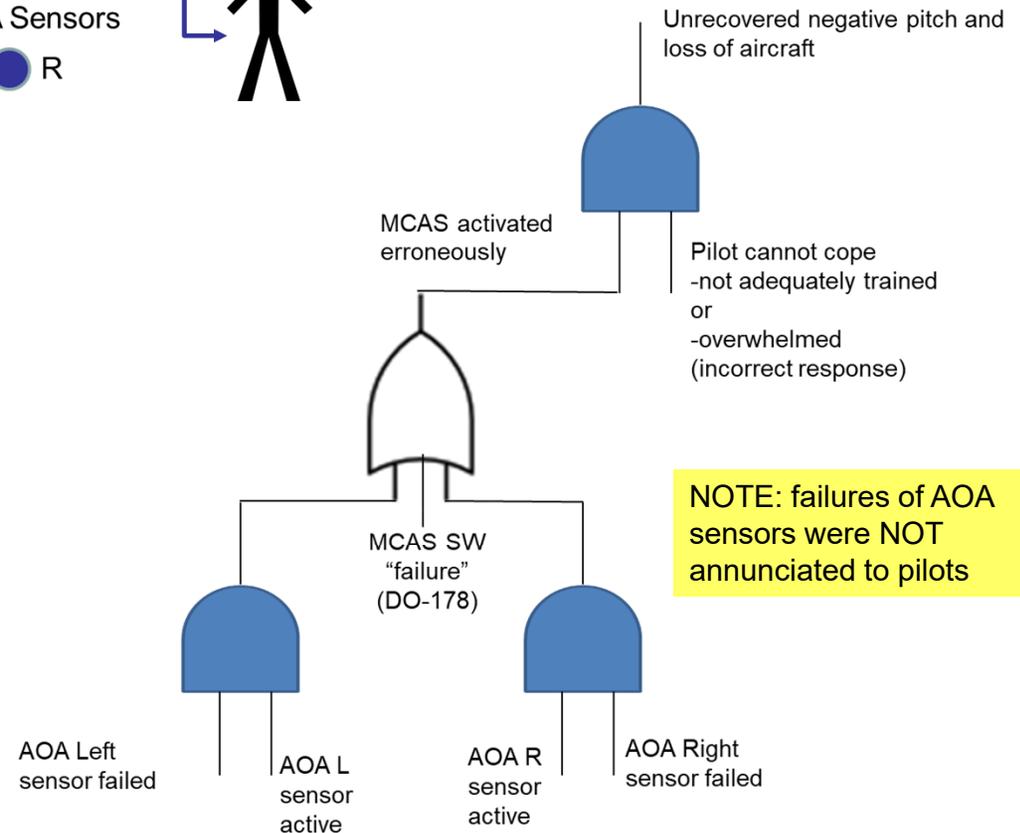
Partial Fault Tree

Unrecovered negative pitch and loss of aircraft

MCAS activated erroneously

Pilot cannot cope
-not adequately trained
or
-overwhelmed
(incorrect response)

MCAS SW
"failure"
(DO-178)

AOA Left
sensor failed

AOA L
sensor
active

AOA R
sensor
active

AOA Right
sensor failed

NOTE: failures of AOA sensors were NOT annunciated to pilots
